Stream Assessment of Rocky River Tributary

Kami Miracle, Bryce Tipton

Baldwin Wallace University, Department of Biology and Geology

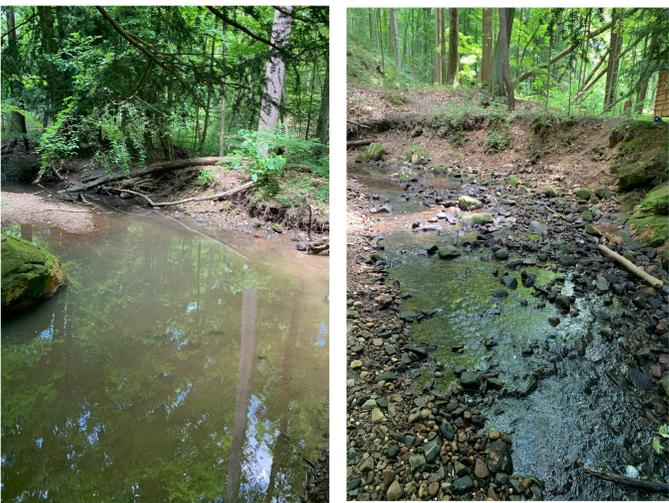
Major pool (left) and riffle (right) studied in the habitat evaluation.

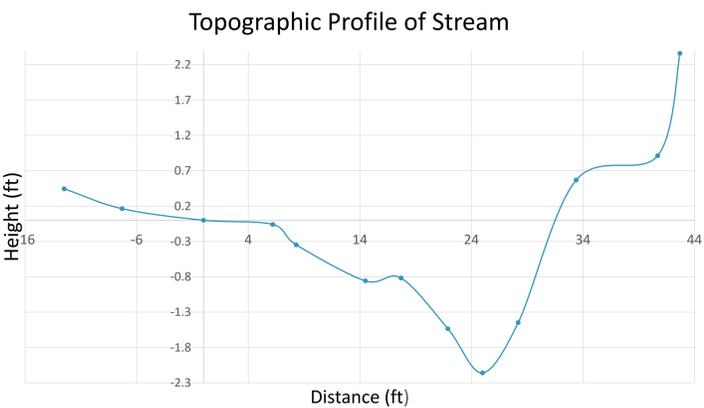
The section shows the lack of connectivity between the channel and the floodplain. This stresses the banks if there were to be an increase of discharge of the stream.
